Rimkus Consulting Group, Inc.
Eight Greenway Plaza, Suite 500
Houston, TX 77046
(800) 580-3228 Telephone
(713) 623-4357 Facsimile

Re: RCG File No: 11009971
LLV Number: 0209452
VMF Location: 1530 Greensmark Drive in Houston, Texas
Subject: Final Report

Rimkus Consulting Group, Inc. was retained to examine LLV 0209452, VIN 1GBCS10E4M2908832. The fire occurred on June 13, 2016 at around 12:30 P.M. the operator of the vehicle at the time of the fire, was unavailable for interview but reportedly stated the vehicle's engine died while delivering mail on his route and backfired during subsequent attempts to restart it. Soon thereafter, smoke was observed from beneath the hood as well as flames.

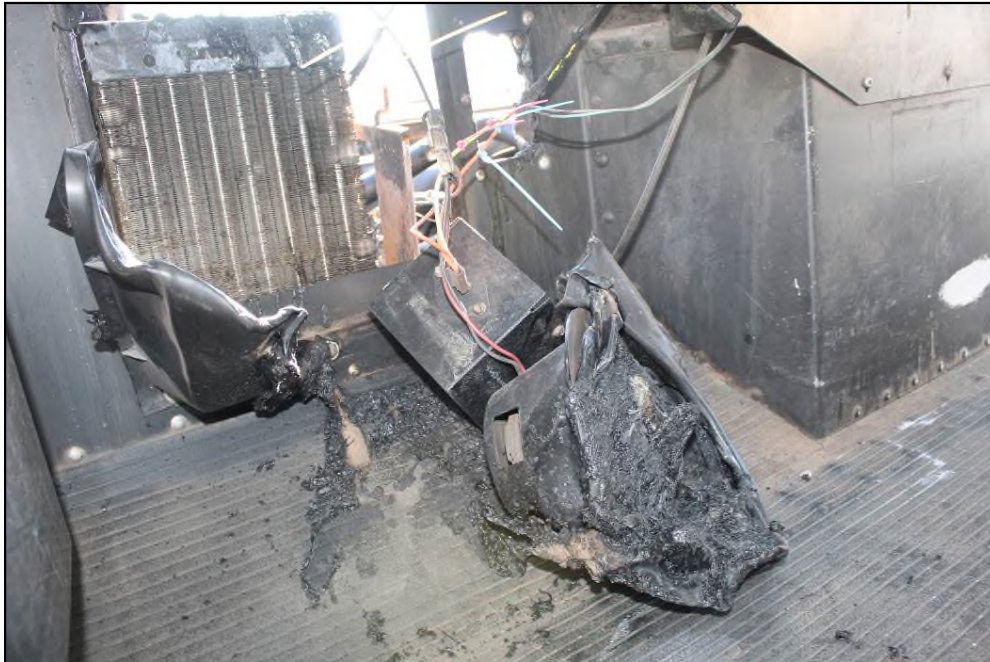
Photograph 7
Remains of the blower motor and housing.

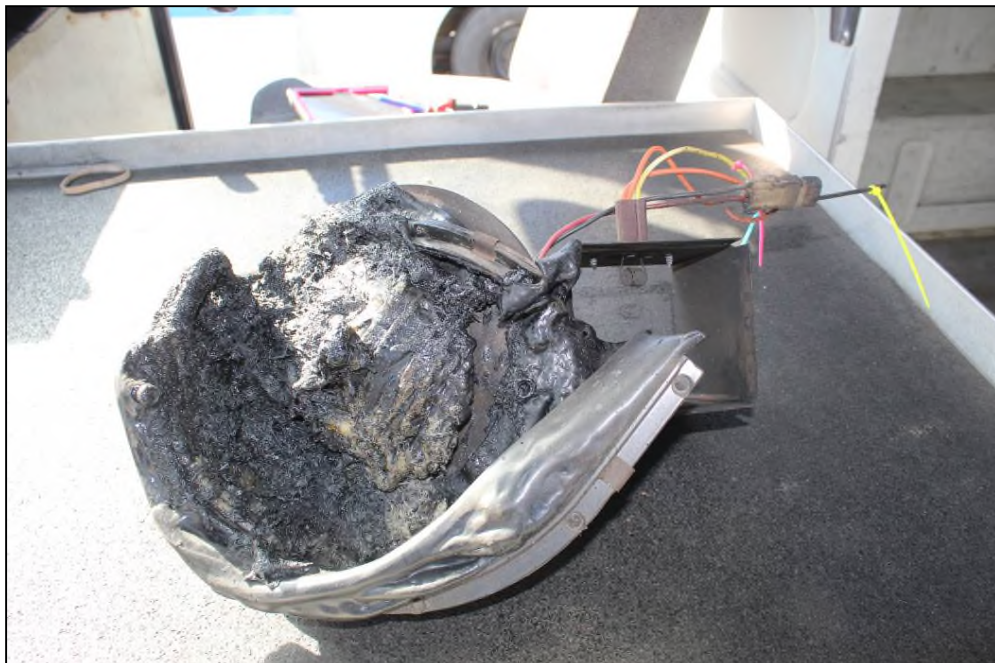
Photograph 8
Remains of the blower motor and housing.

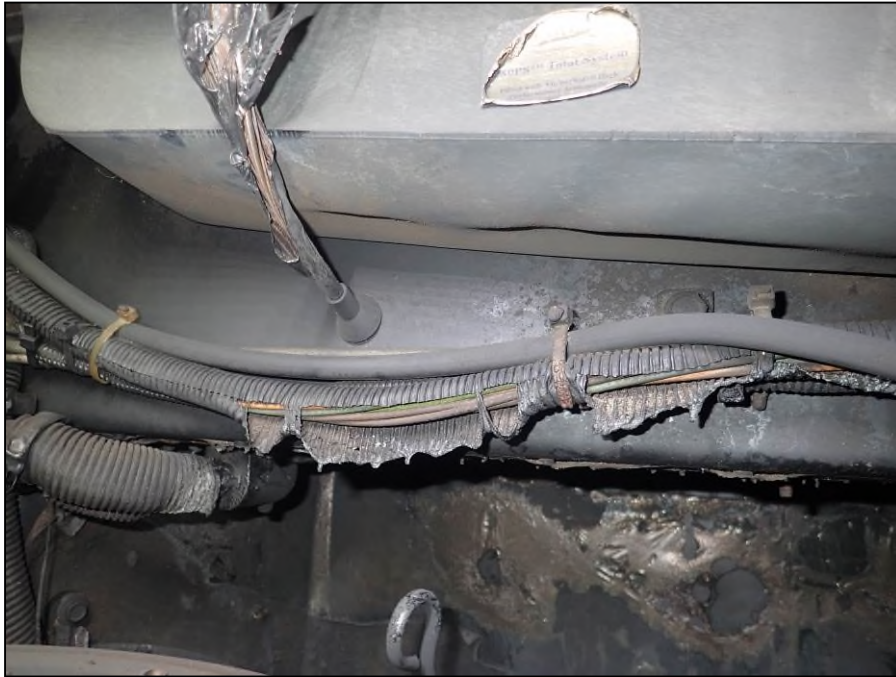
Photograph 4
Engine compartment with collateral thermal damage.

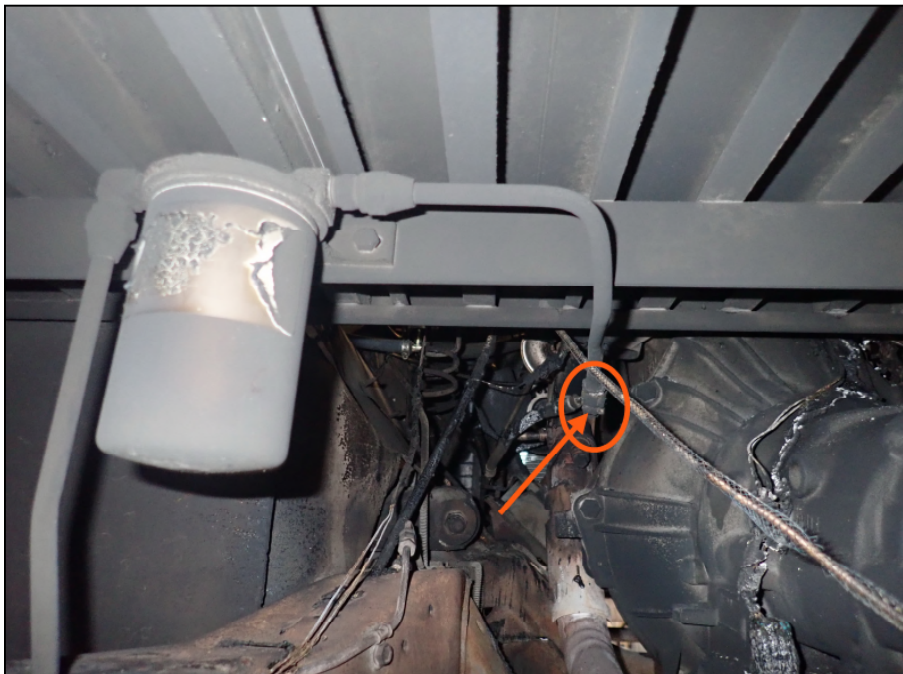
Photograph 9

View of fuel hose failure location.

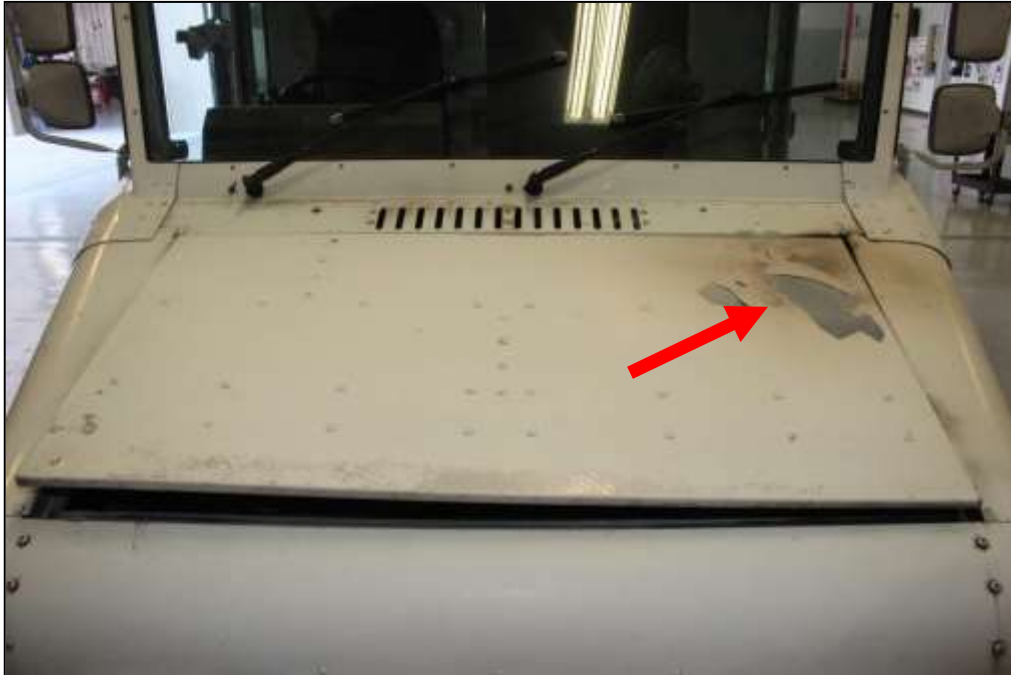
Photograph 1

View of heat damage on the mail side of the hood.

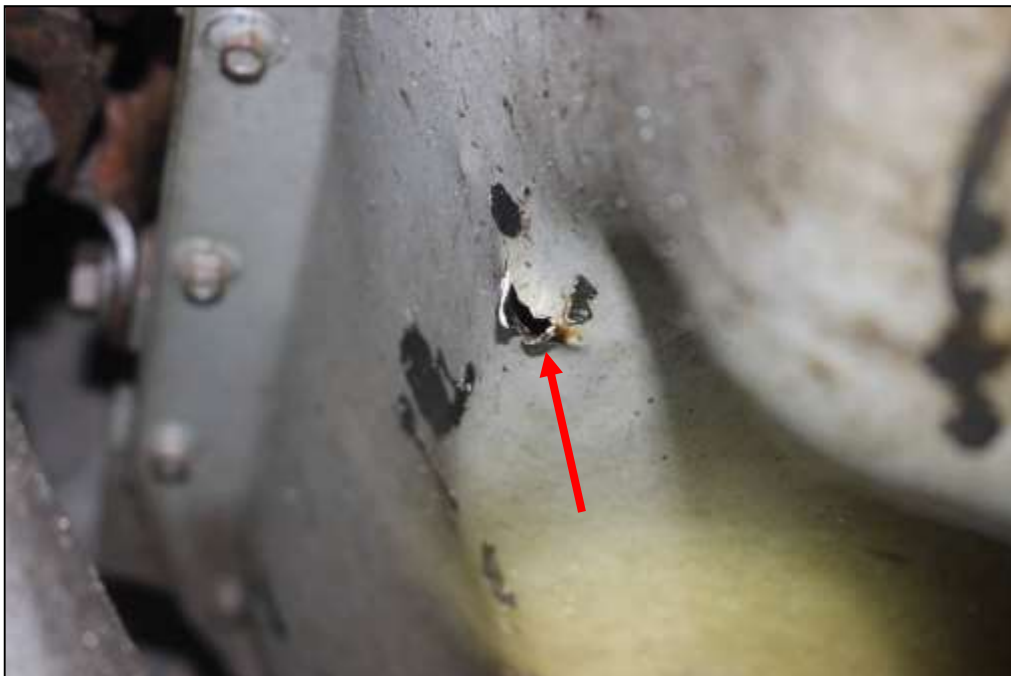
Photograph 4

View of the hole in the oil pan with the metal edges protruding outward.

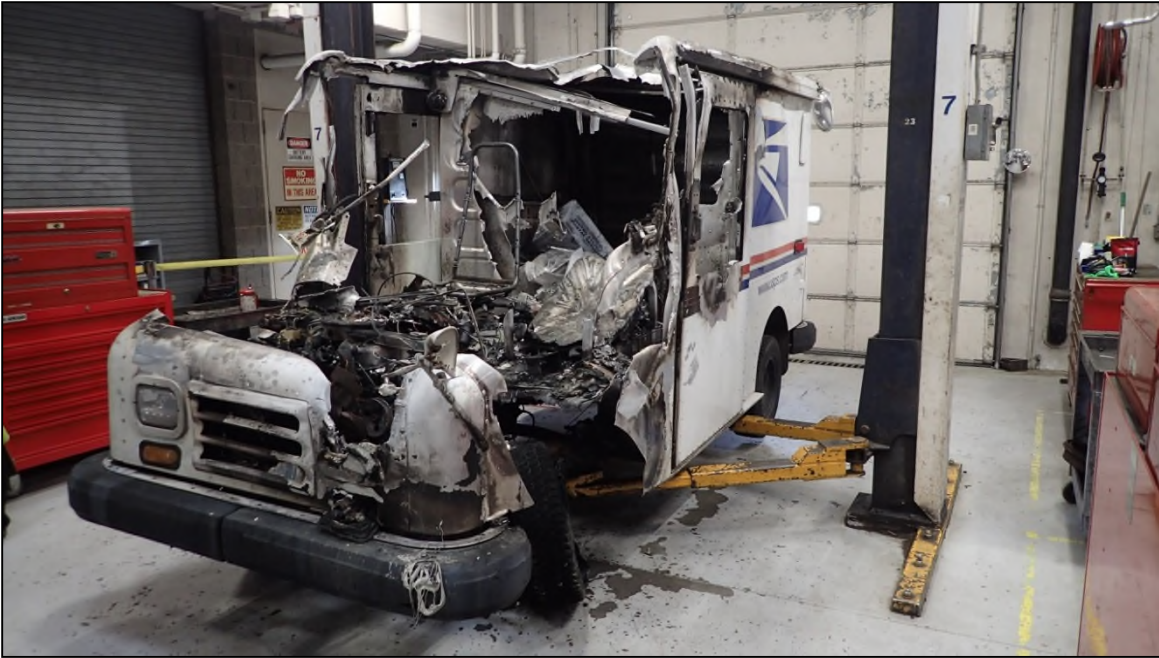
Photograph 1

View of the front and passenger side exterior.

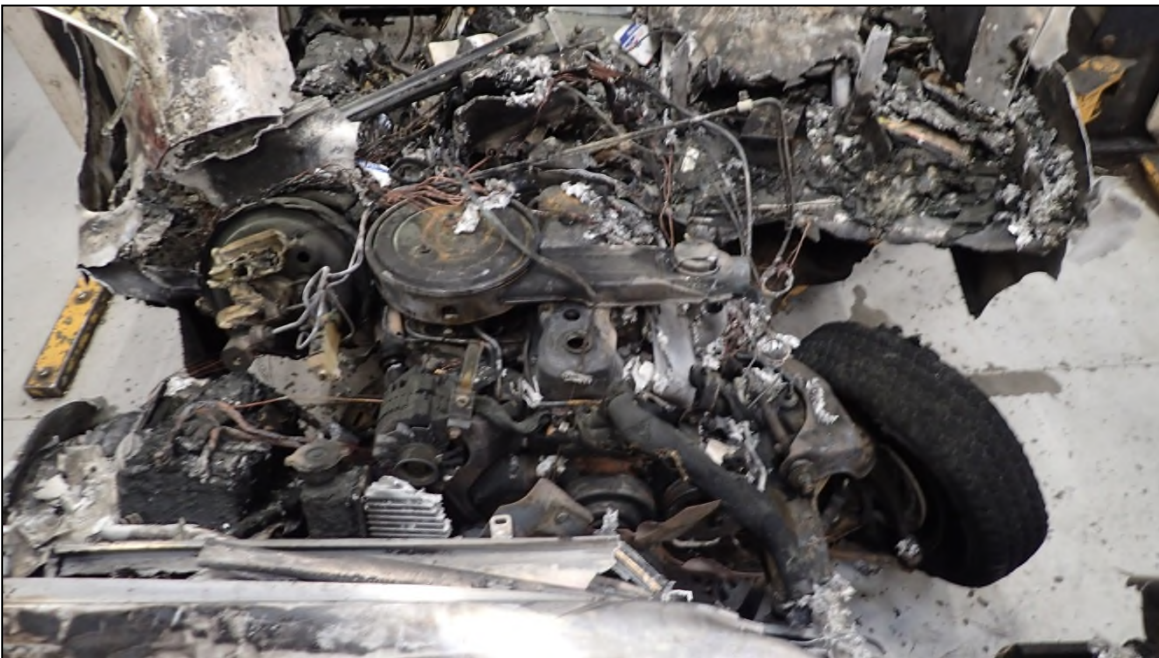
Photograph 2

View of the engine compartment.

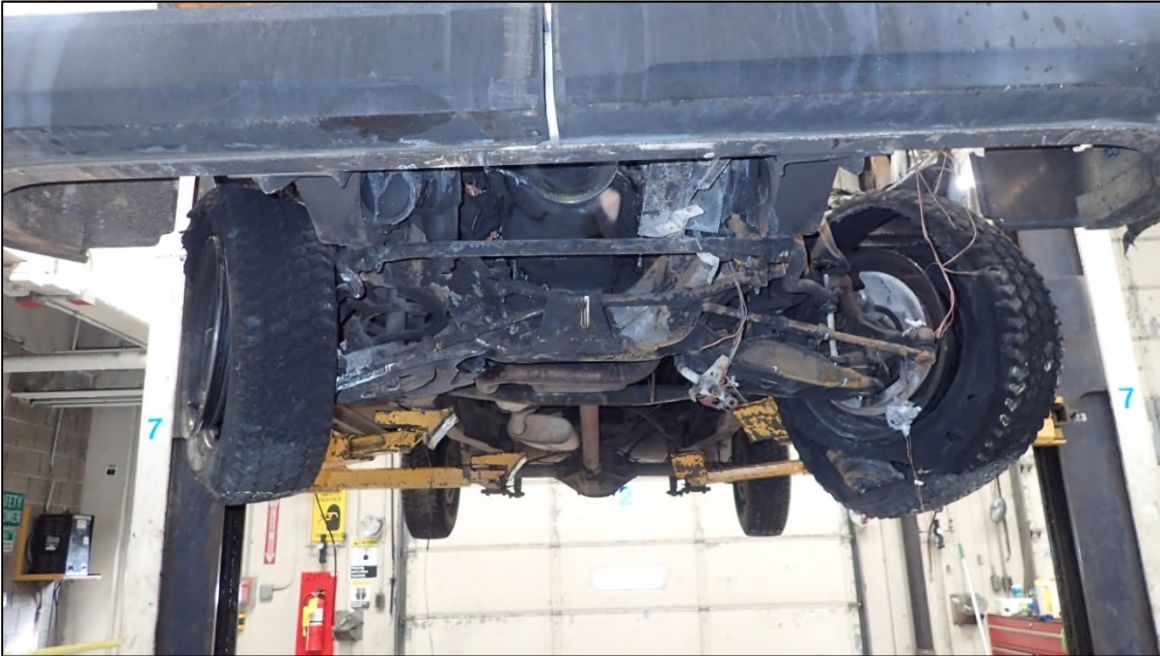
Photograph 5
The undercarriage area.

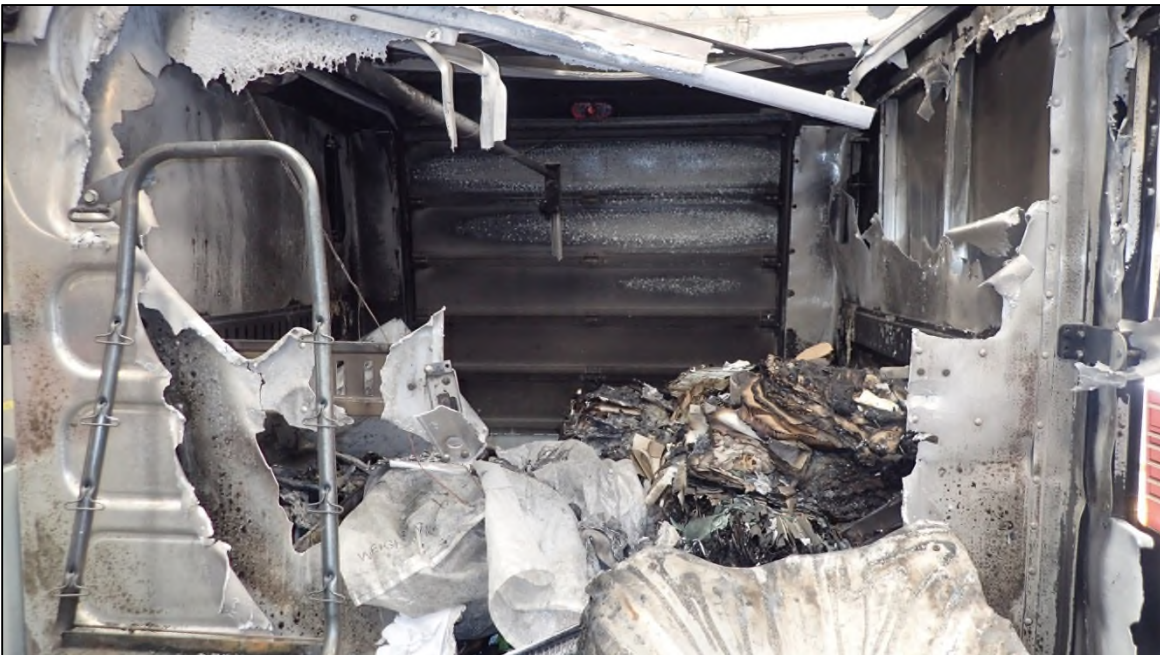
Photograph 6
Cargo area.

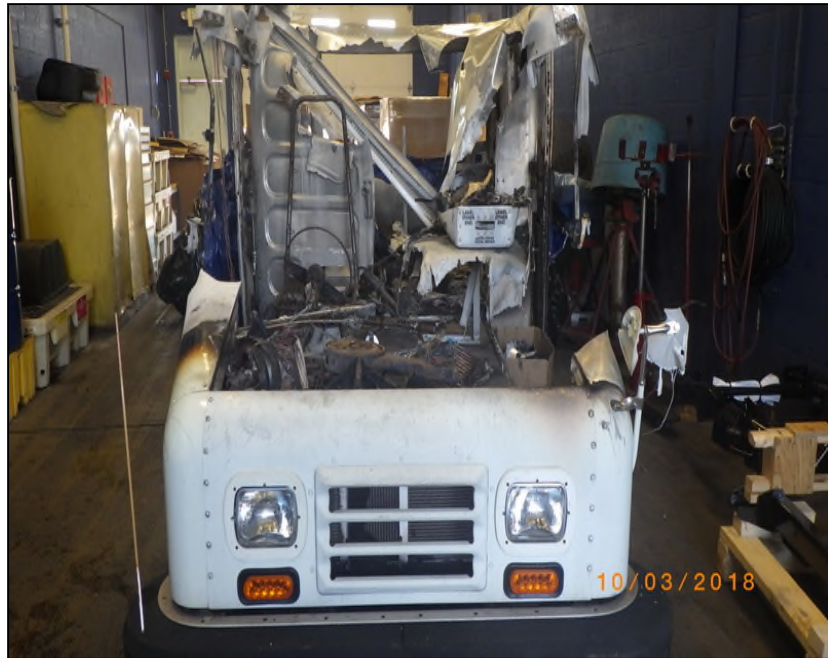
Photograph 1

A view of the exterior front of the vehicle.

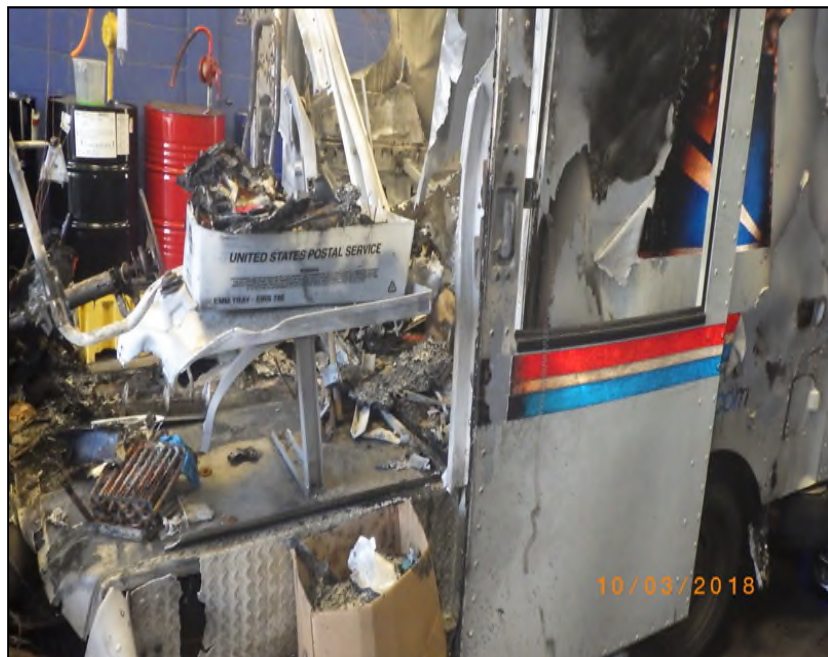
Photograph 2

A view of the exterior left side of the vehicle.

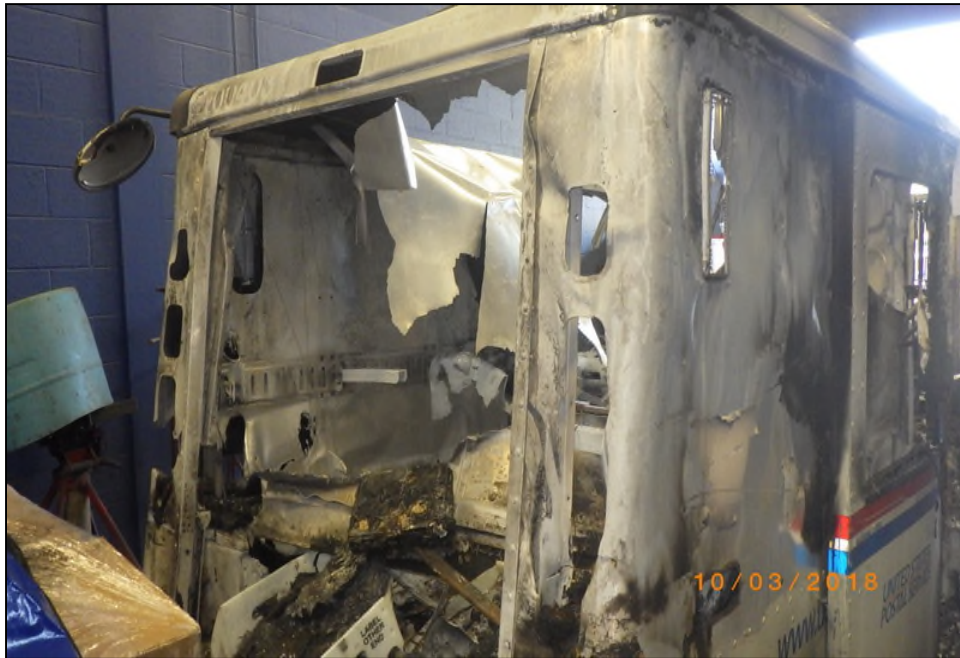
Photograph 3

A view of the exterior rear of the vehicle.

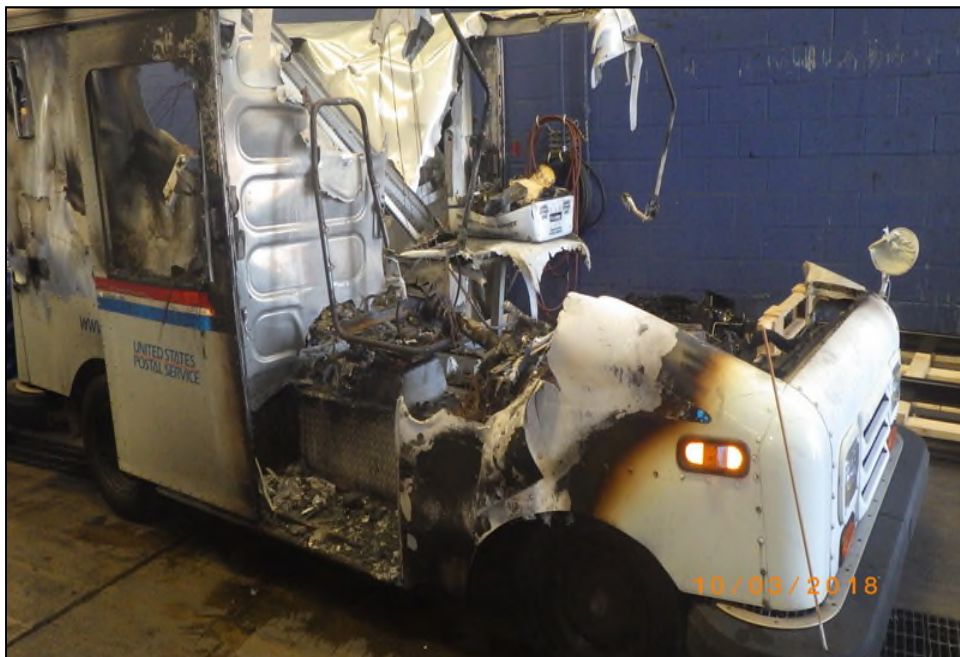
Photograph 4

A view of the exterior right side of the vehicle.

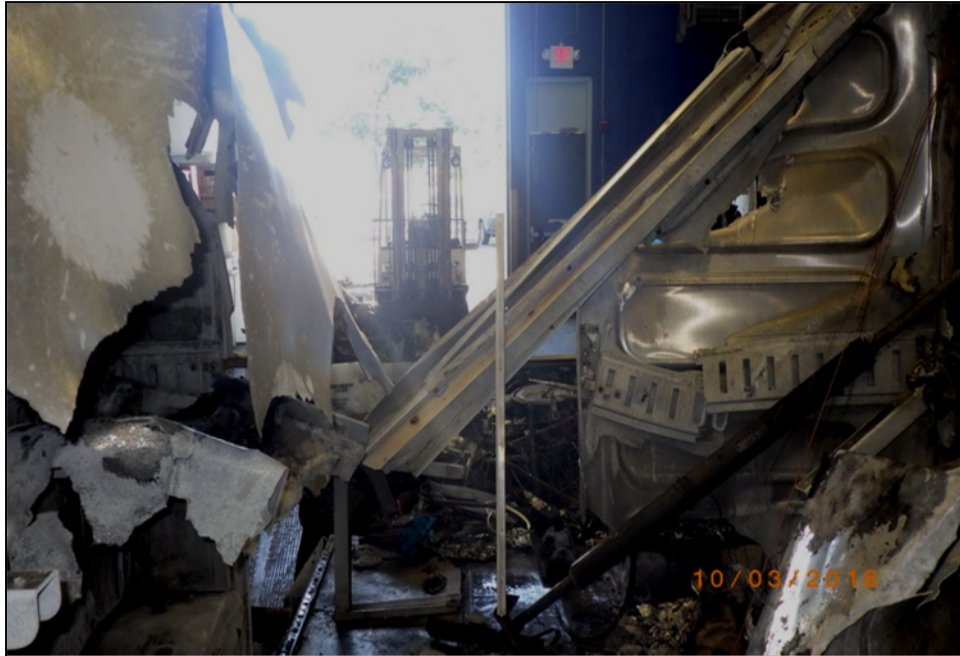
Photograph 5

A view of the interior cargo area of the vehicle.

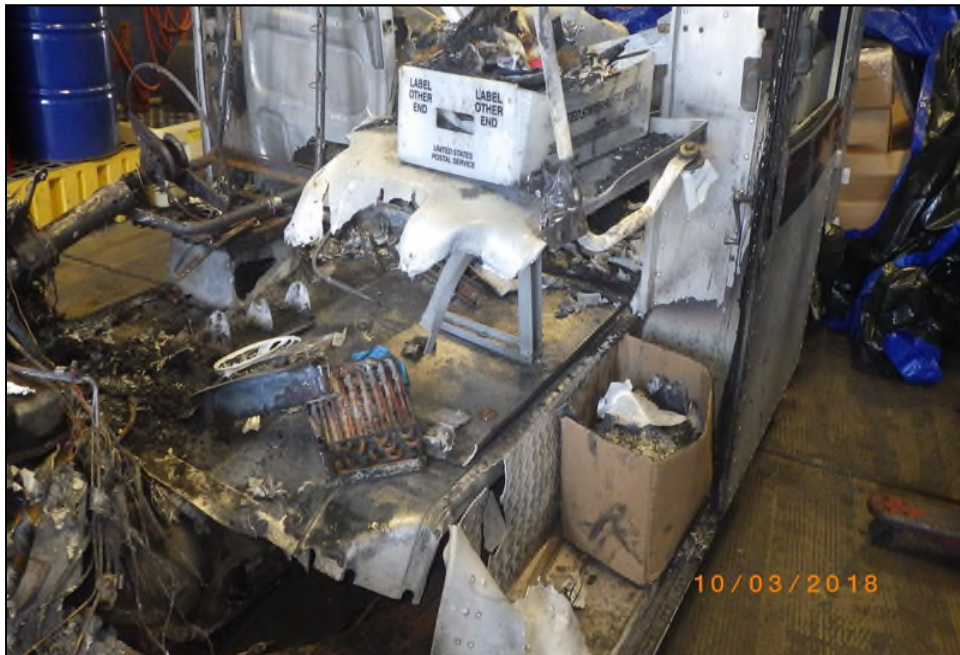
Photograph 6

A view of the interior driver's compartment of the vehicle.

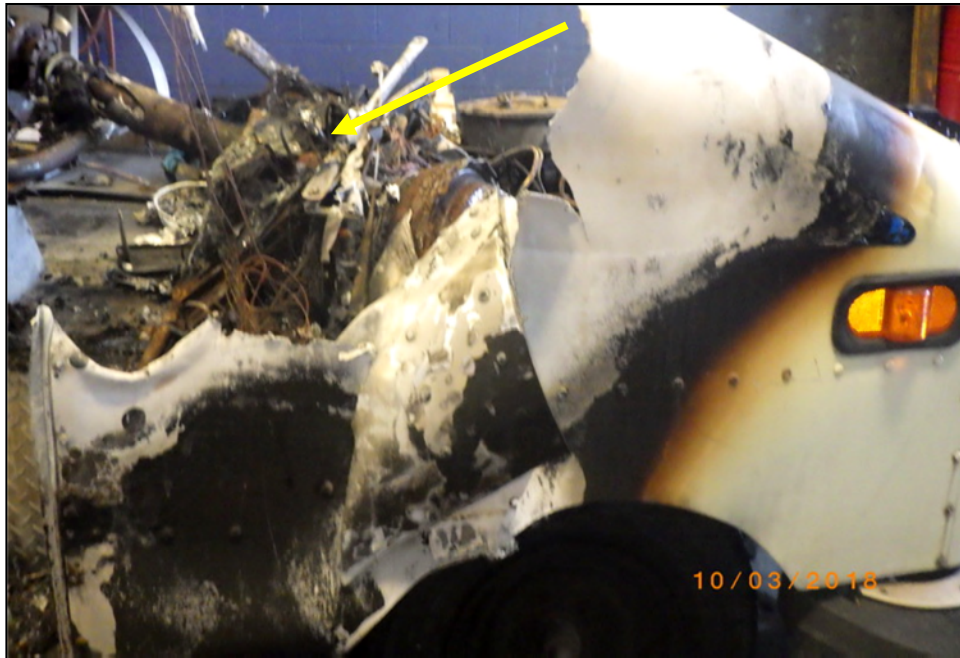
Photograph 7

A view of the dashboard of the vehicle.

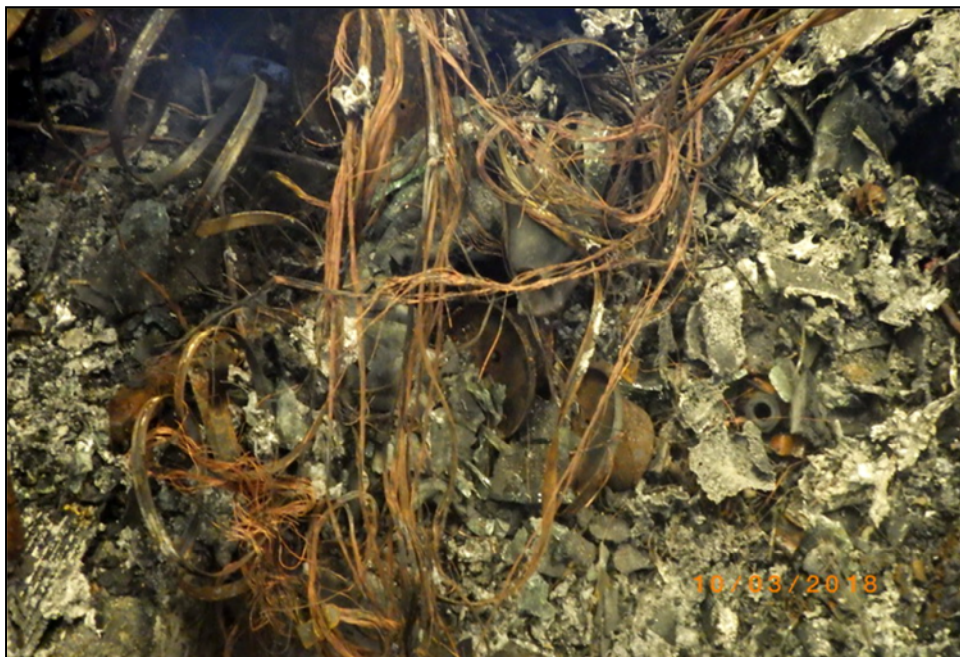
Photograph 8

A view of the fuse panel.

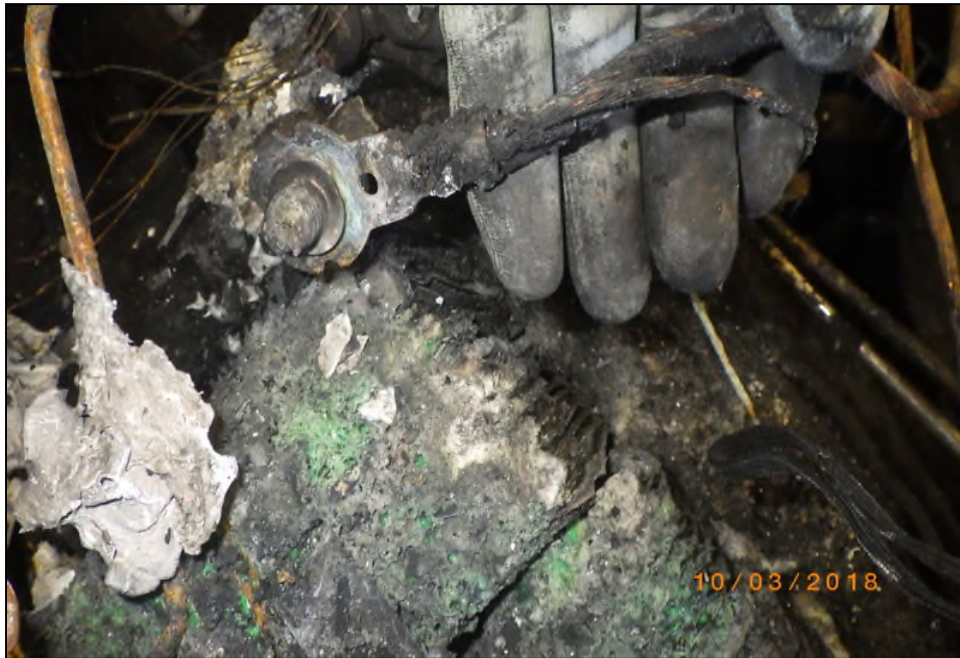
Photograph 9

A view of the battery.

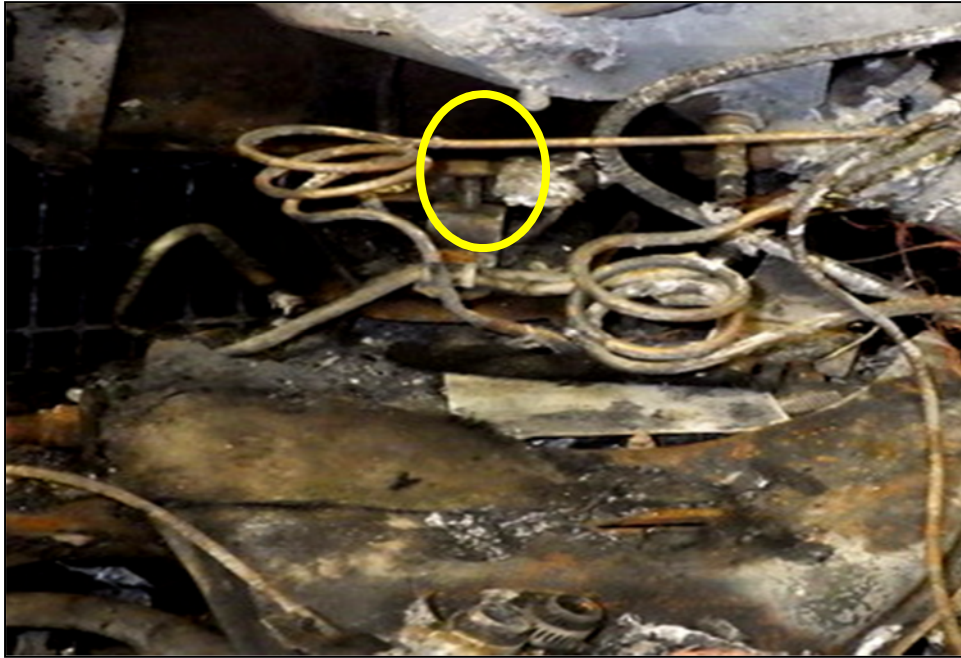
Photograph 11

A view of the motor mount bolt.

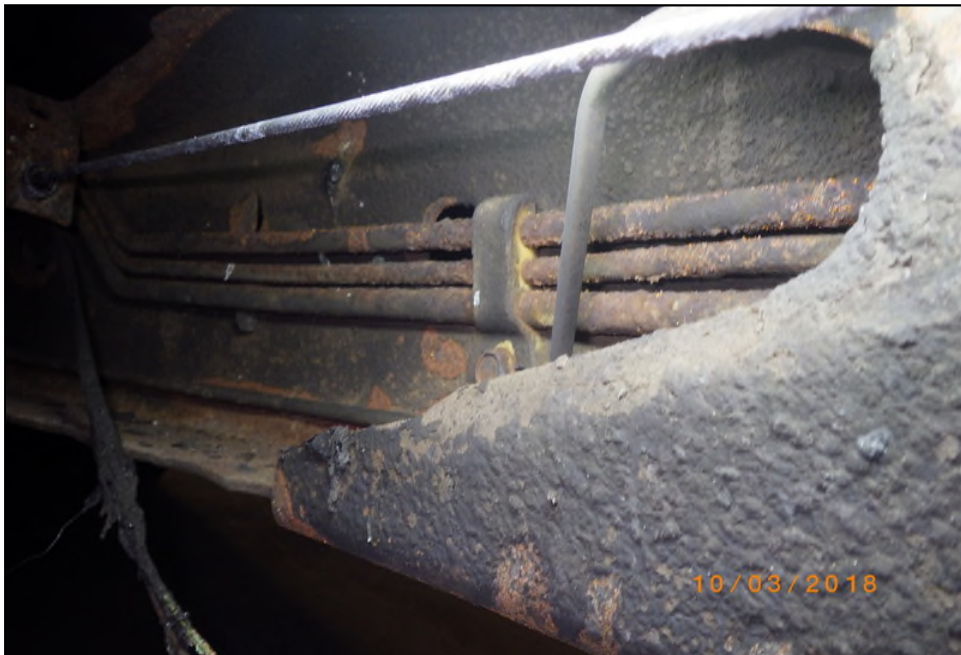
Photograph 12

A view of the fuel line positioned along the undercarriage left frame.

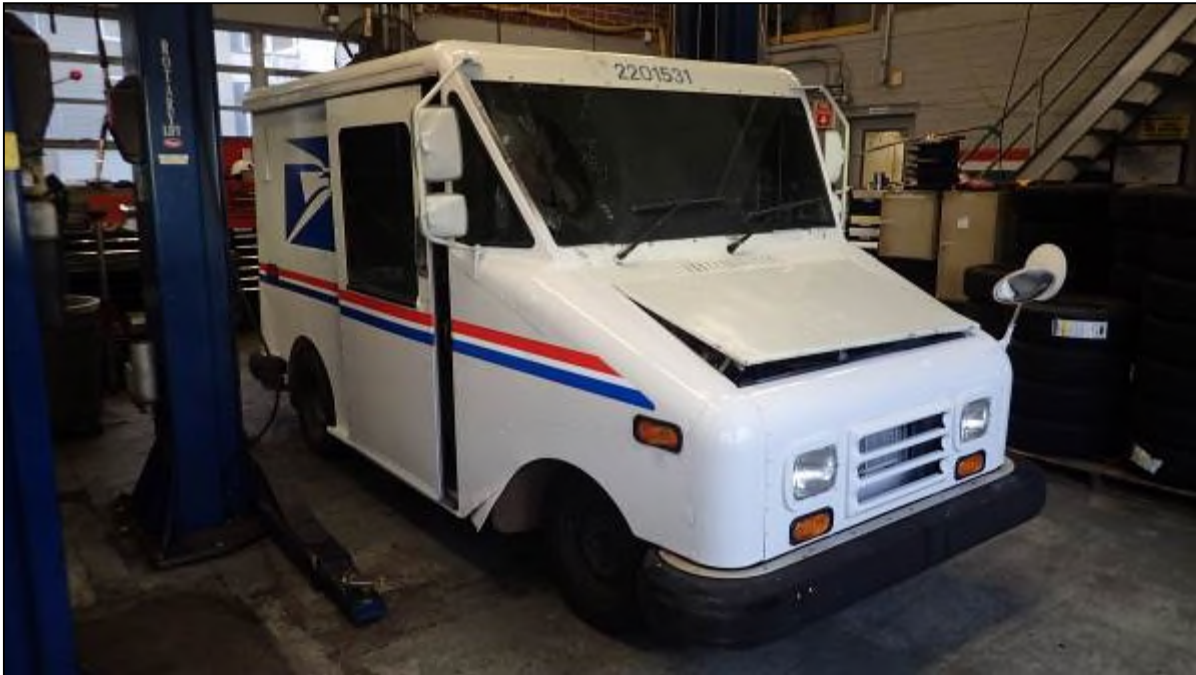
Photograph 1

View of the front and driver's side exterior.

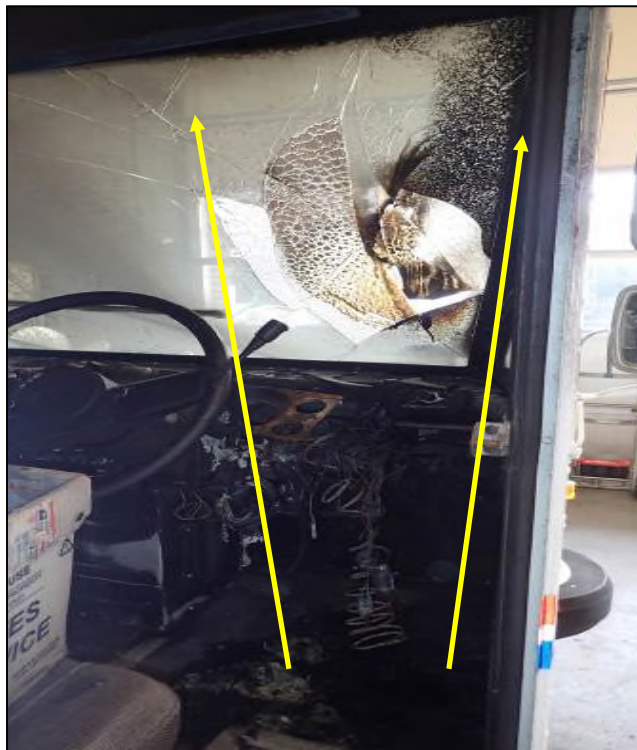
Photograph 2

View of the fire damage along the driver's side dashboard and windshield.

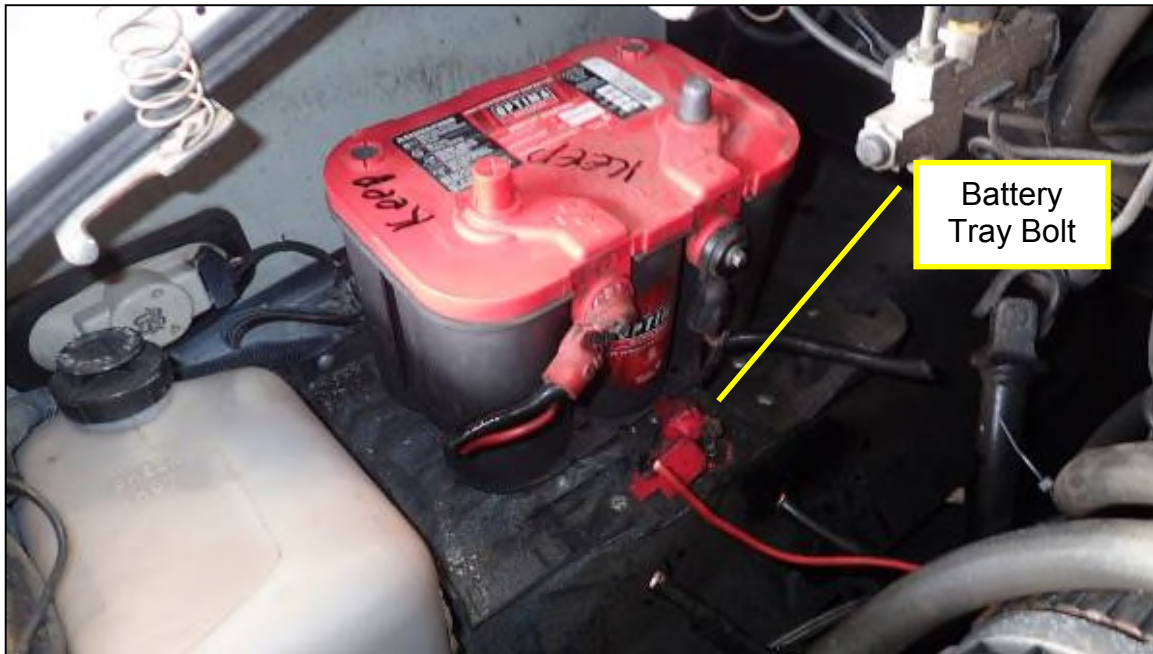
Photograph 3

View of the battery inside the engine compartment after reconstruction.

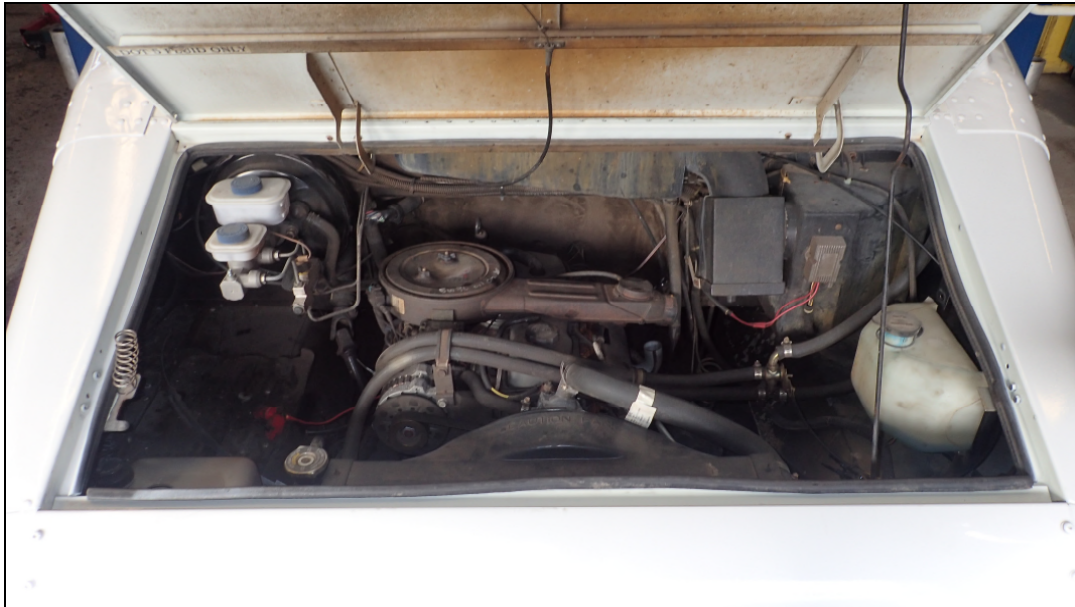
Photograph 5
The engine compartment.

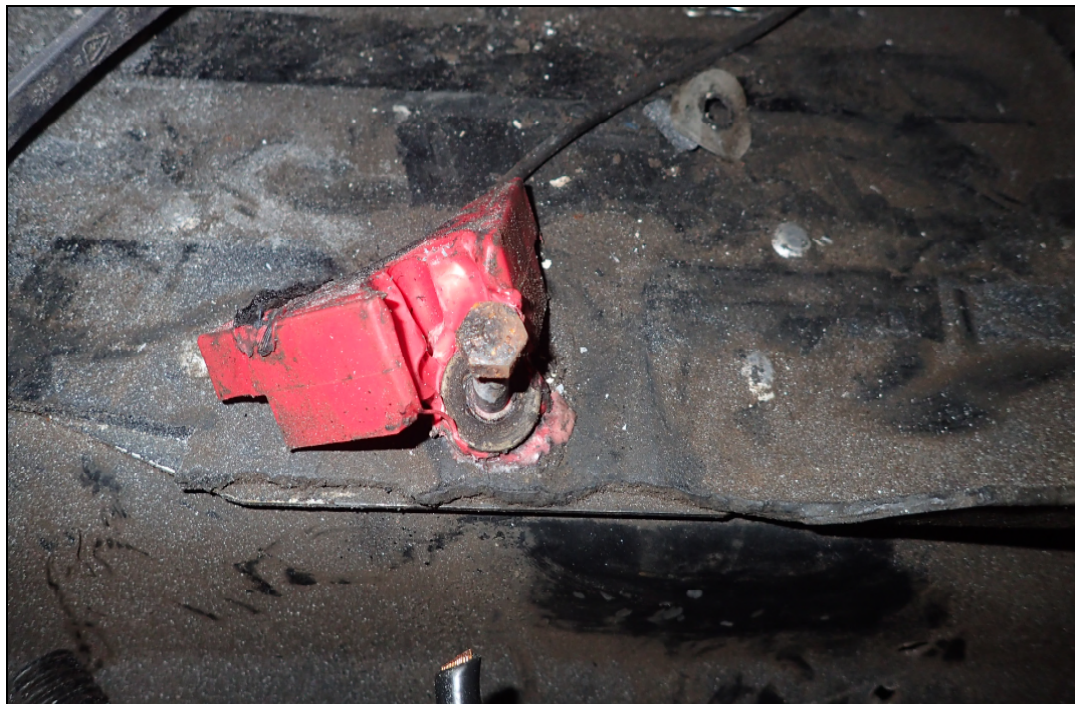
Photograph 6
The battery bolt, observe that the bolt is not tightened down to secure the battery.

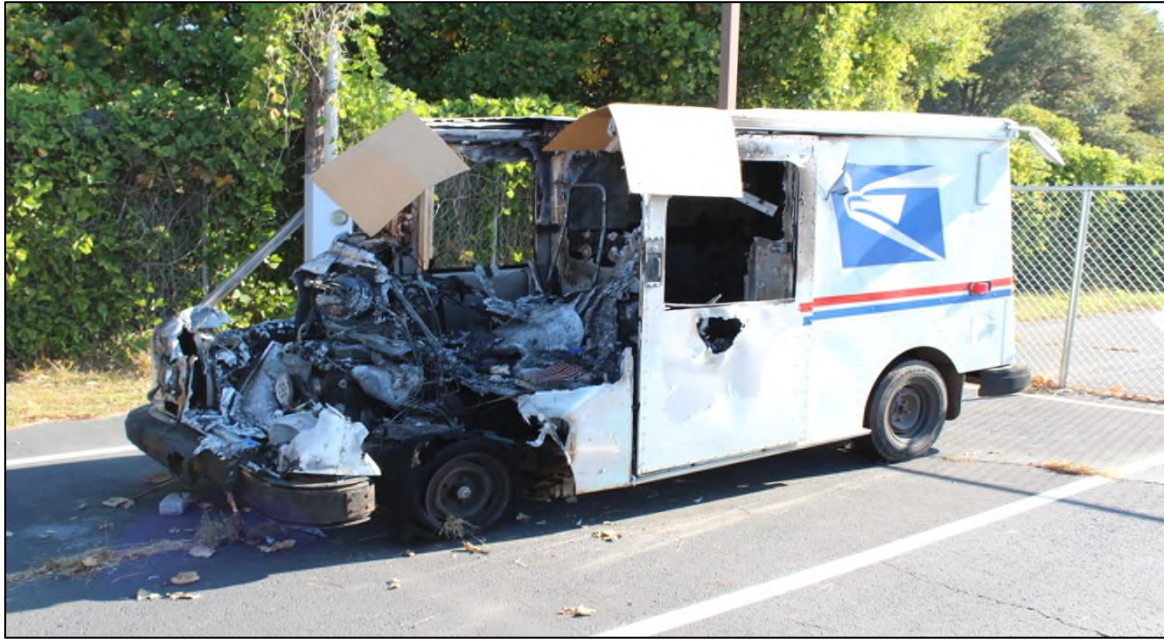
Photograph 1

1992 Chevrolet LLV 2201737, VIN: 1GBCS10A3N2909355.

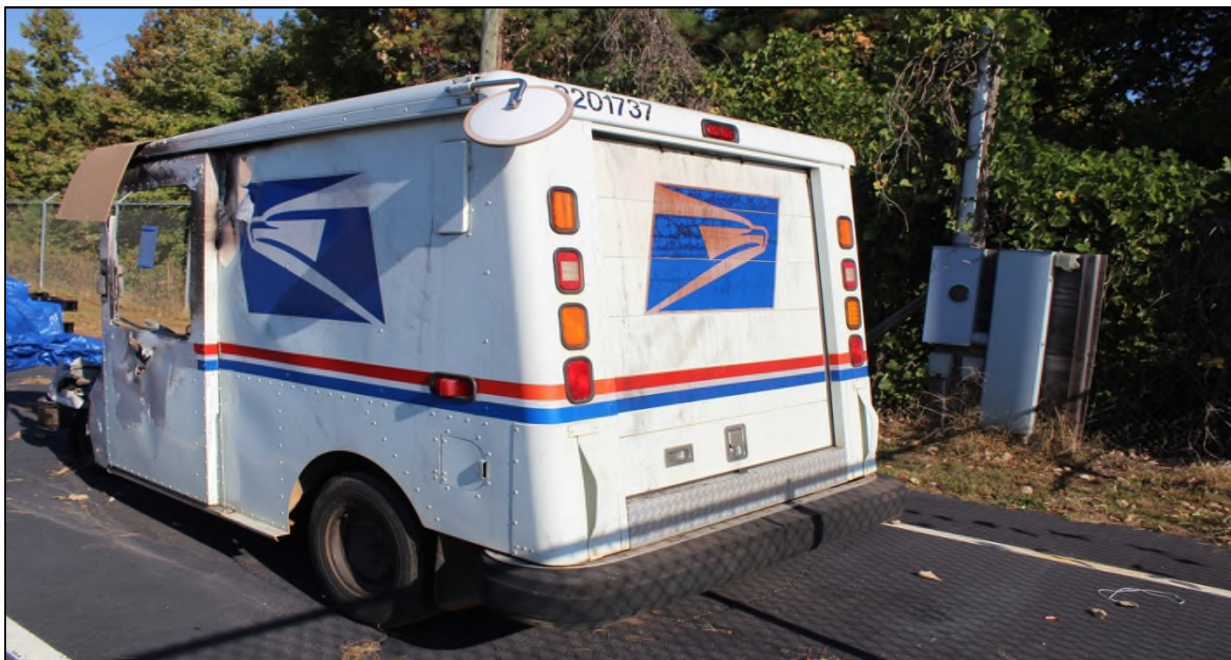
Photograph 6

The left rear of the vehicle.

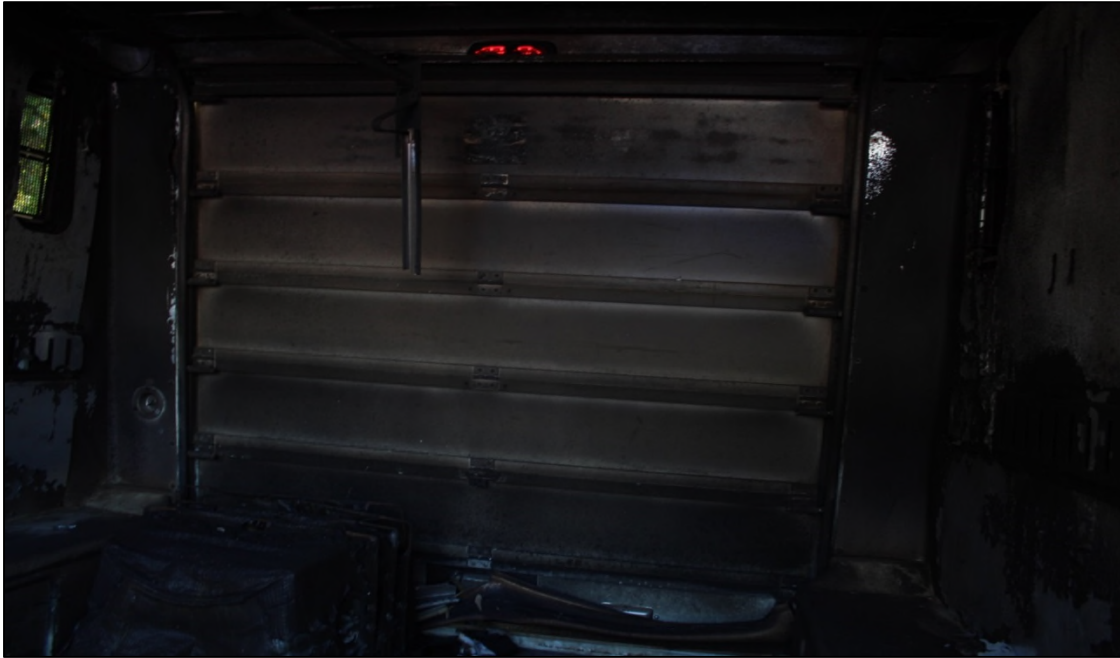
Photograph 7

The cargo area of the vehicle.

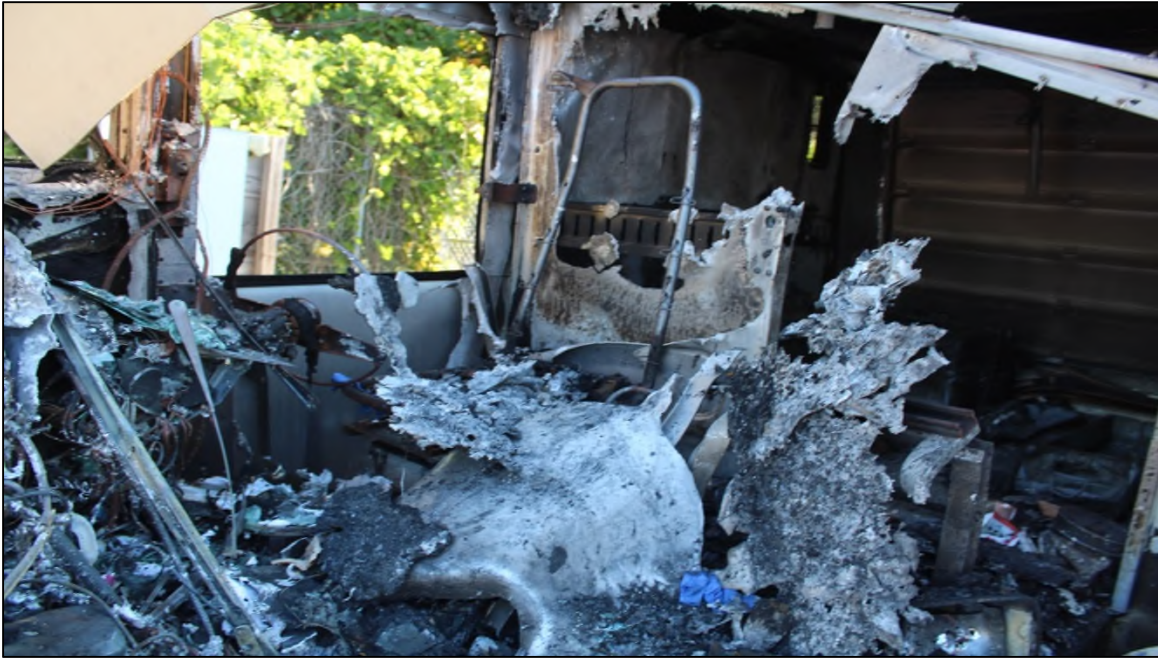
Photograph 9

The passenger compartment of the vehicle.

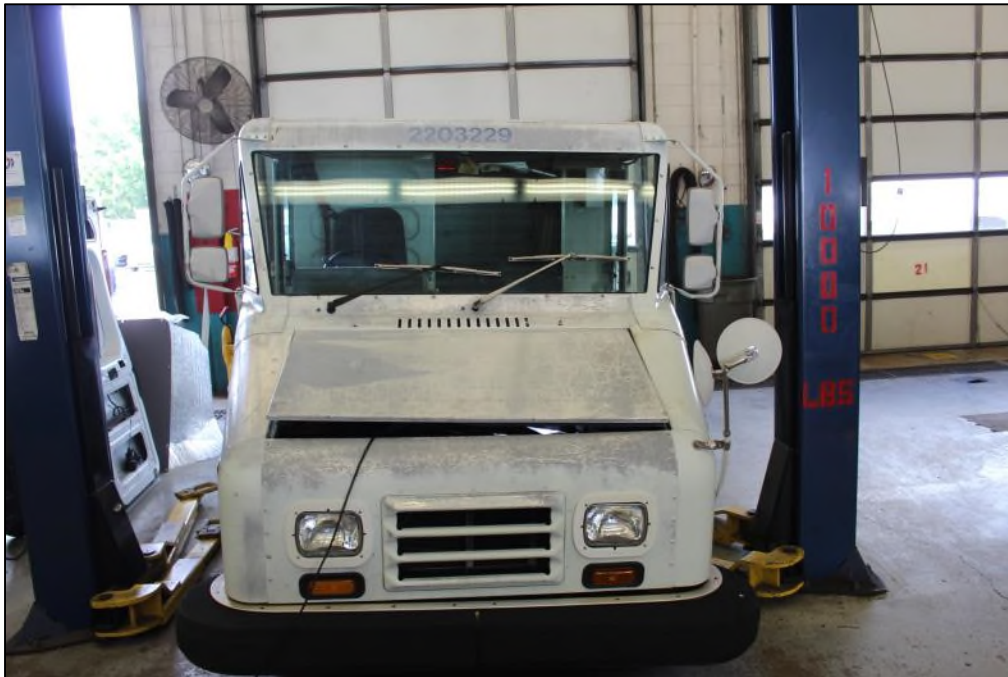
Photograph 1

Front view of the vehicle.

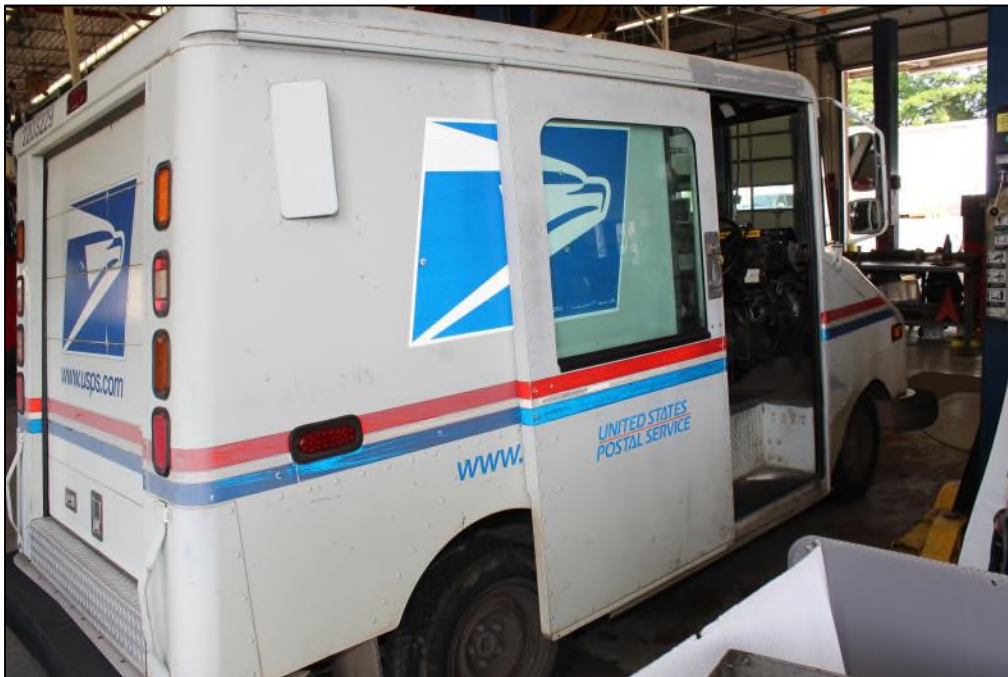
Photograph 2

Right side and rear of the vehicle.

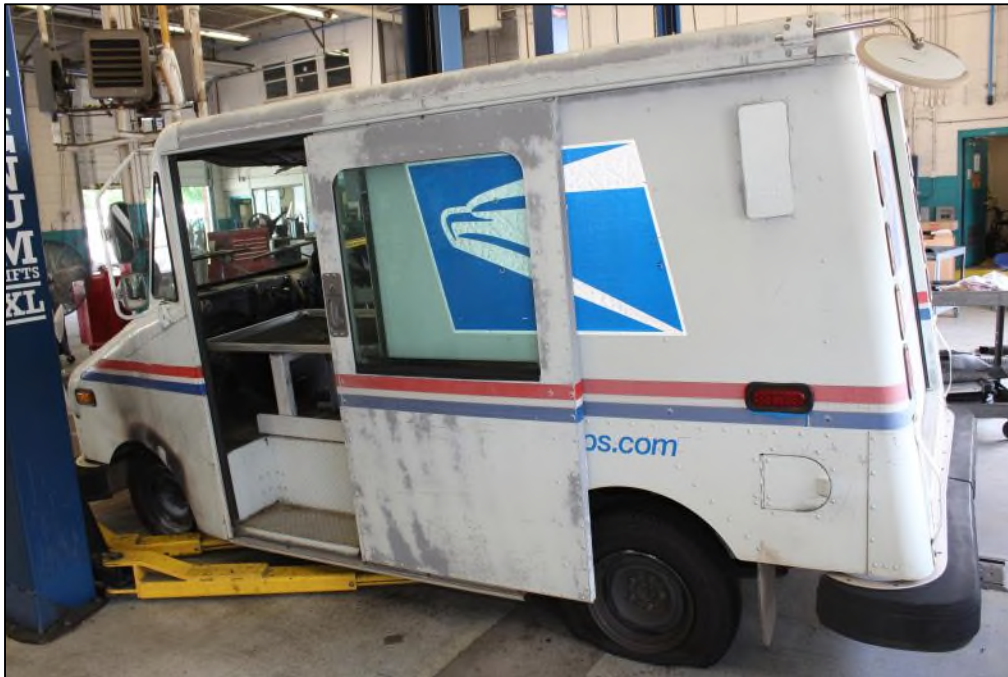
Photograph 3

Left side of the vehicle.
